## ELLE™ Installation Critical Steps.

### **PURPOSE OF THIS INSTRUCTION**

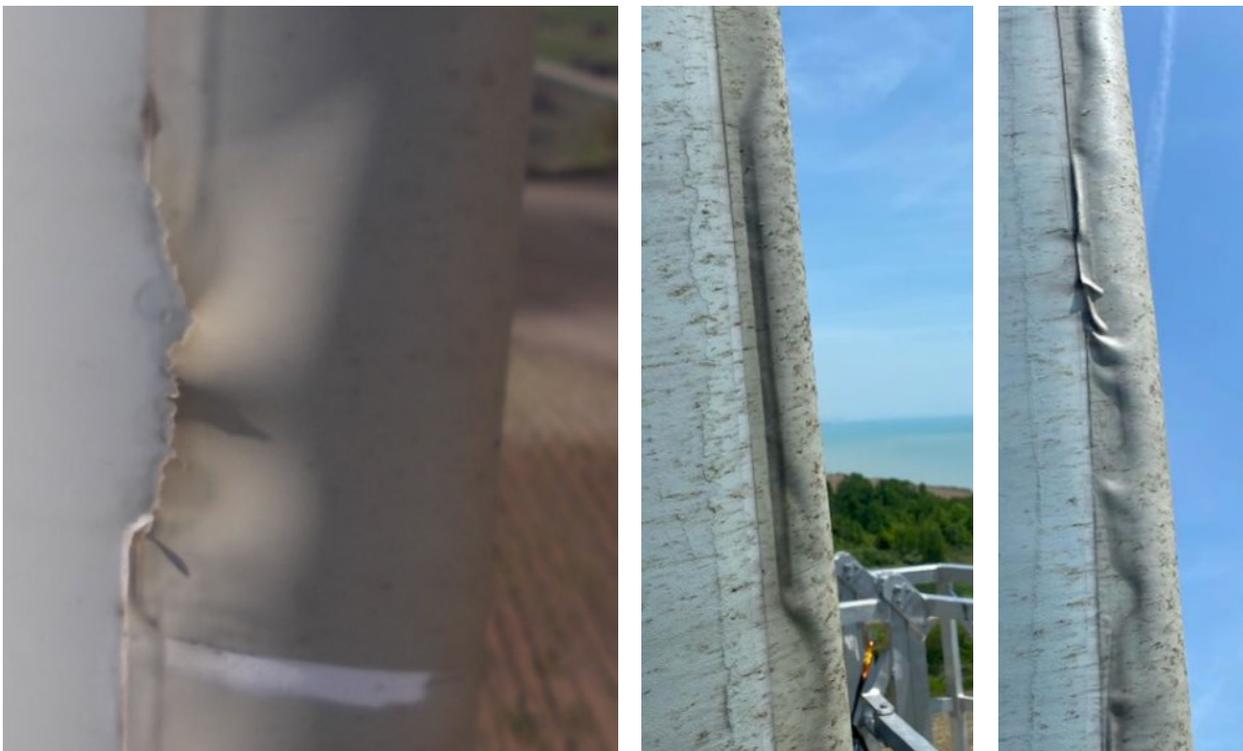
Make sure that there are no air bubbles outside spec. in the installation. Air bubbles tend to expand over time, eventually loosening the edge of the ELLE.

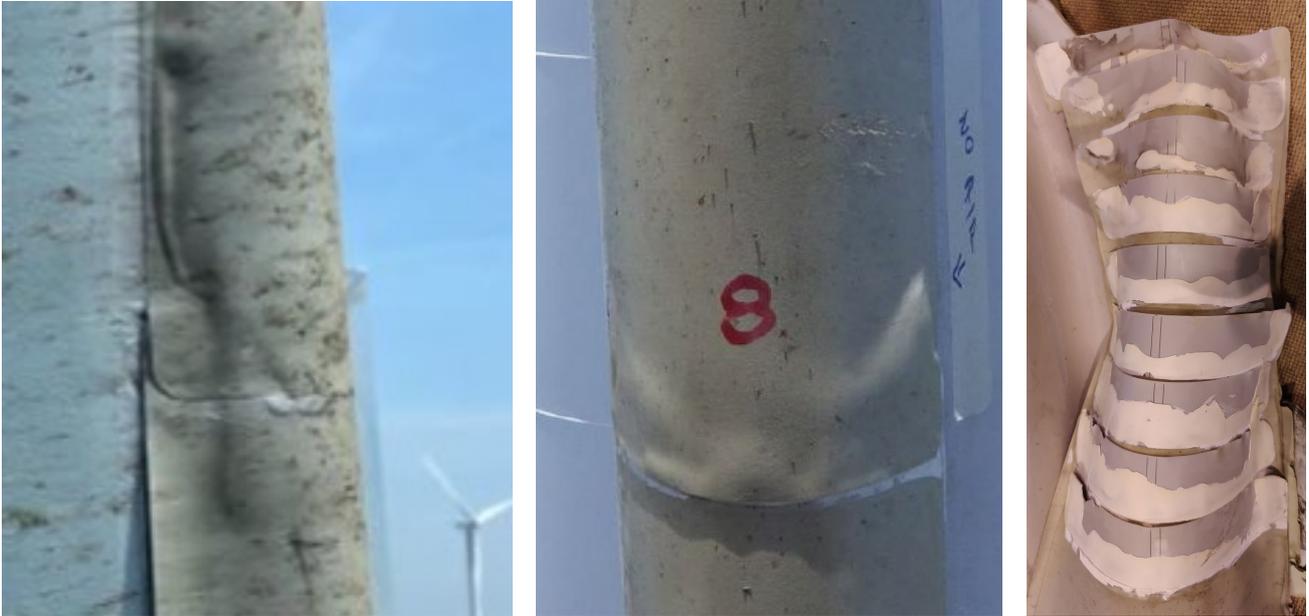
The overlaps must be sealed underneath, all the way to the pre-installed adhesive.

This will prevent any water penetration to the installation continuing to the next ELLE and any missing sealer will furthermore react as an air bubble and tend to expand over time, eventually loosening the edge of the ELLE.

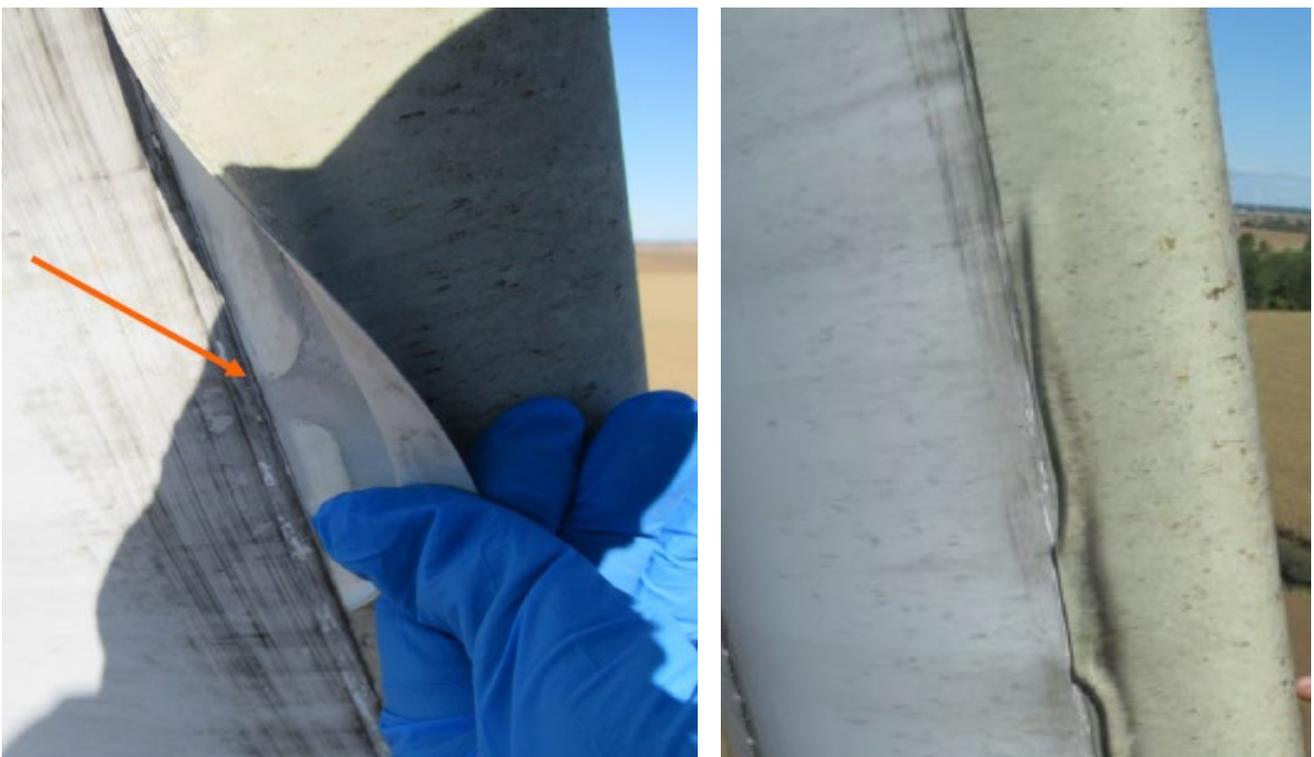
All the edges at the ELLE must be perfectly sealed without any gaps or missing sealer. Avoid sealing more than one ELLE at a time as the viscosity of the sealer slowly increases, making it more difficult to spread evenly. Any gaps will cause a bridge that will allow water to pass into the PSA adhesive. Water contamination of the PSA adhesive will significantly reduce the adhesion of the ELLE to the blade. Any missing sealer will react as an air bubble and tend to expand over time, eventually loosening the edge of the ELLE.
